# Manhole Inspection Summary

Manhole # S51AA\_028MH

Insp Date: **2/27/08 9:01 AM**

**Location** Address: **Ellwood**

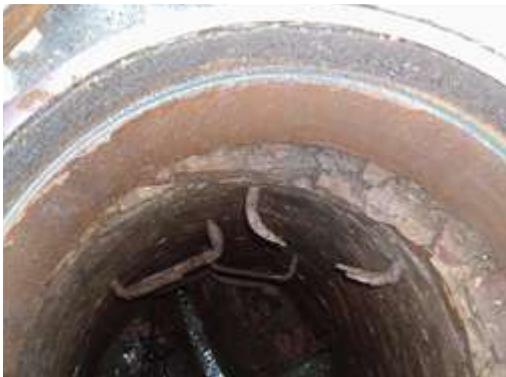
Defect 2

Count: **5** Missing: **1** ☒ **Corroded**

Missing Step

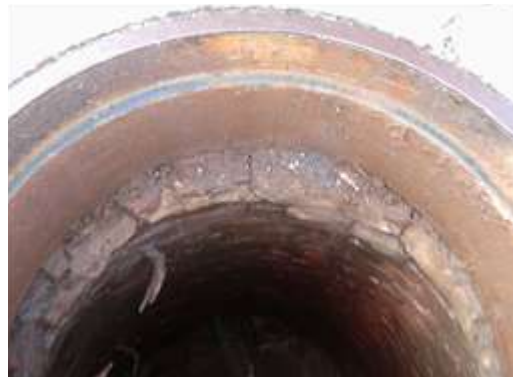
Defect 1

Offset: **3** (in.)

Offset

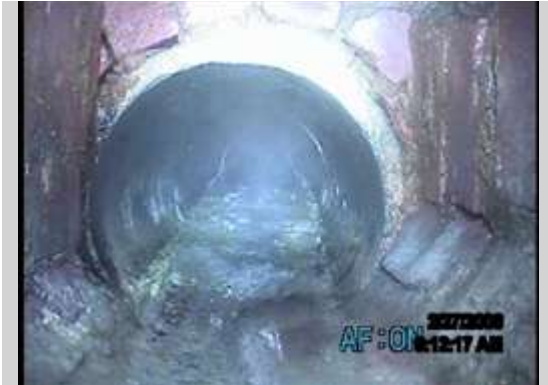
12 O'Clock Outflow

8 in. Circular Gravity Sewer  
Pipe Out @ 12 O'Clock

Pipe Height: **8.4** (in.) Rod and Bar (Angled)  
Pipe Material: **Clay** ☐ Pipe Lined  
Invert Depth: **9.40** (ft.) Flow Characteristics: **Fast**  
Deposits: ☒ None ☐ Mud ☐ Sludge ☐ Debris ☐ Grease  
Silt Depth: (in.) Deposits Extent:  
Infiltration: **None** Pipe Seal Cond: **Sound**

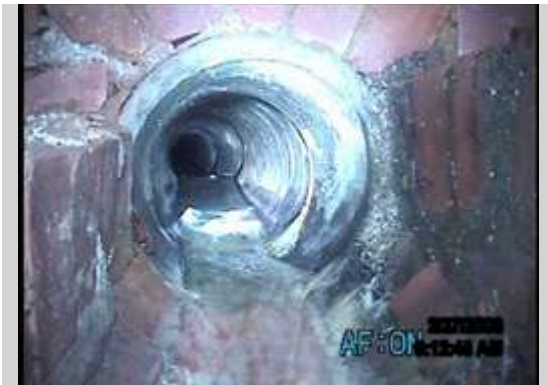
3 O'Clock Inflow

8 in. Circular Gravity Sewer  
Pipe In @ 3 O'Clock

Pipe Height: **8.4** (in.) Rod and Bar (Angled)  
Pipe Material: **Clay** ☐ Pipe Lined  
Invert Depth: **9.00** (ft.) Flow Characteristics: **Fast**  
Deposits: ☒ None ☐ Mud ☐ Sludge ☐ Debris ☐ Grease  
Silt Depth: (in.) Deposits Extent:  
Infiltration: **None** Pipe Seal Cond: **Sound**

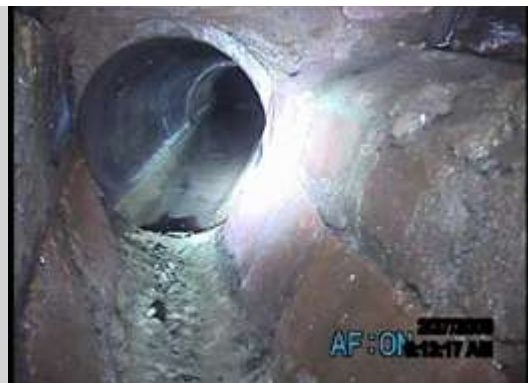
9 O'Clock Inflow

Pipe In @ 9 O'Clock

Invert Depth: **9.00** (ft.) Flow Characteristics: **Slow**
